Mould in Treated Timber

Surface Mould is Harmless and Will Not Affect the Structural Integrity of Treated Timber

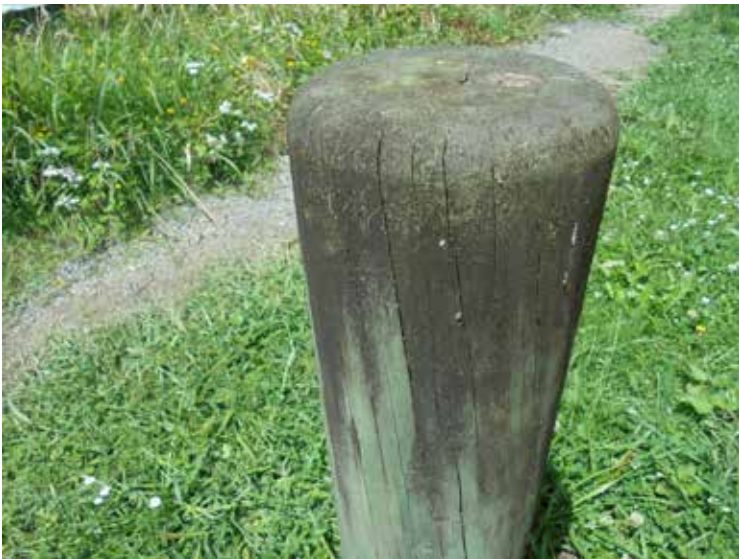
H-4 Treated Post: Structurally unaffected by Surface Mould

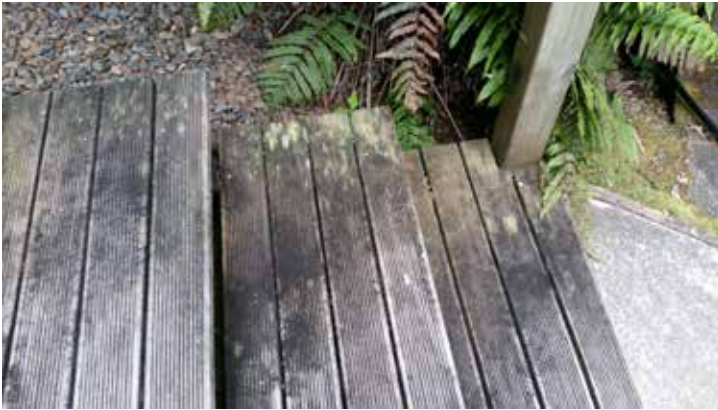
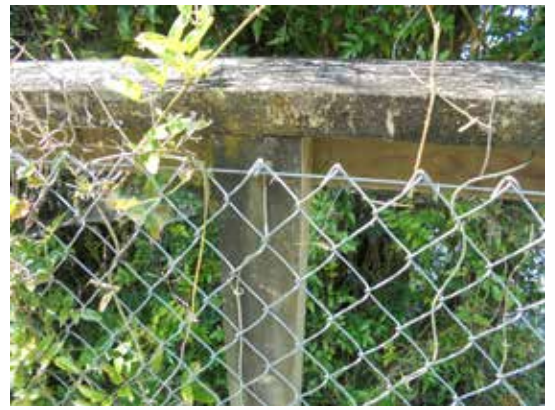
Above are some images of mould on timber treated with CCA preservative from H-3.2 & H-4 Hazard classes. The timber is aged and has been in place possibly for 30 years, it has been covered in black mould since being erected.

The timber remains sound and in good condition for it's age despite the surface mould being present

The only concern for treated framing is that mould discolours the surface. Keeping the timber completely dry is all that is needed to inhibit further growth however it is possible to wipe the surface with a mouldicide or a solution of bleach to remove the dark patches and return the timber to its original appearance
